# Clearbrook Waterworks District 2016 Water Quality Report

**Clearbrook Waterworks District  
2016 Water Quality Report**

**APRIL 2017**

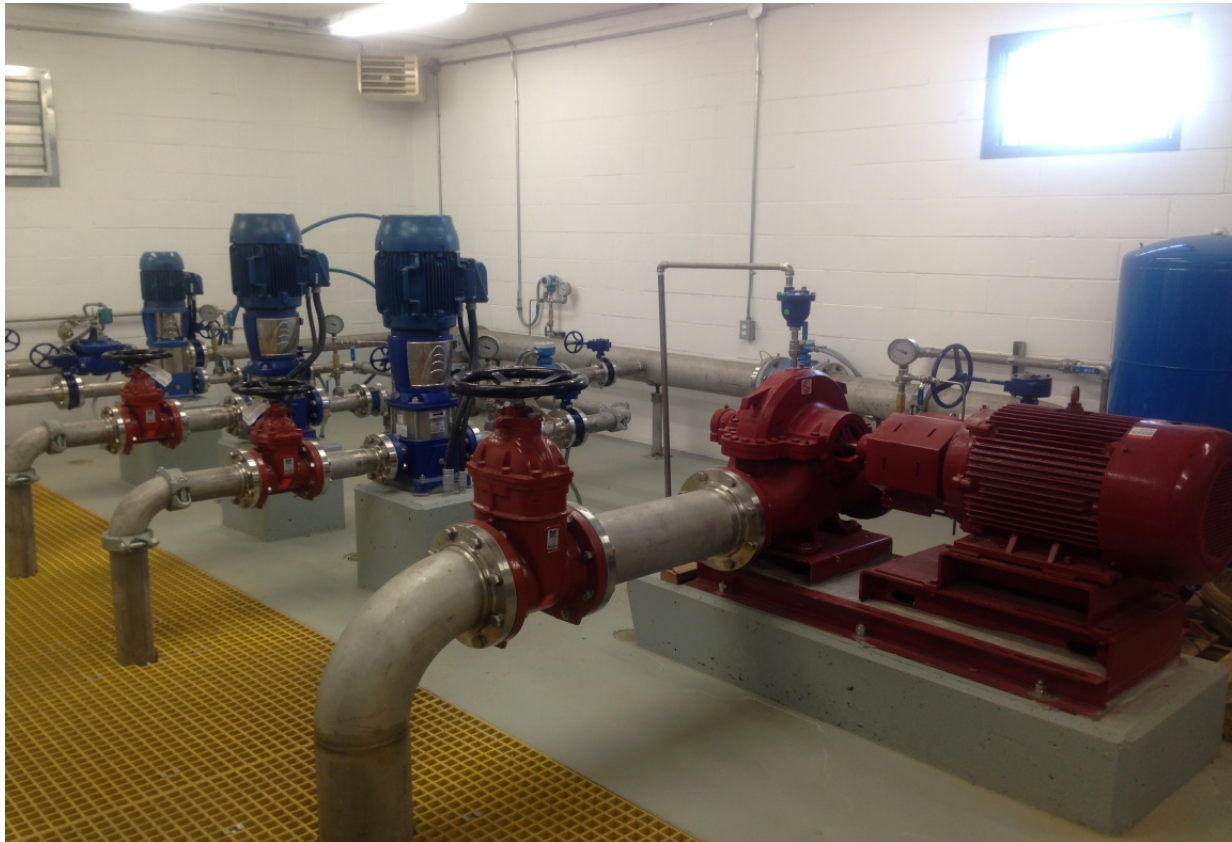
**IMAGE | PUMP STATION AT THE RESERVOIR SITE**

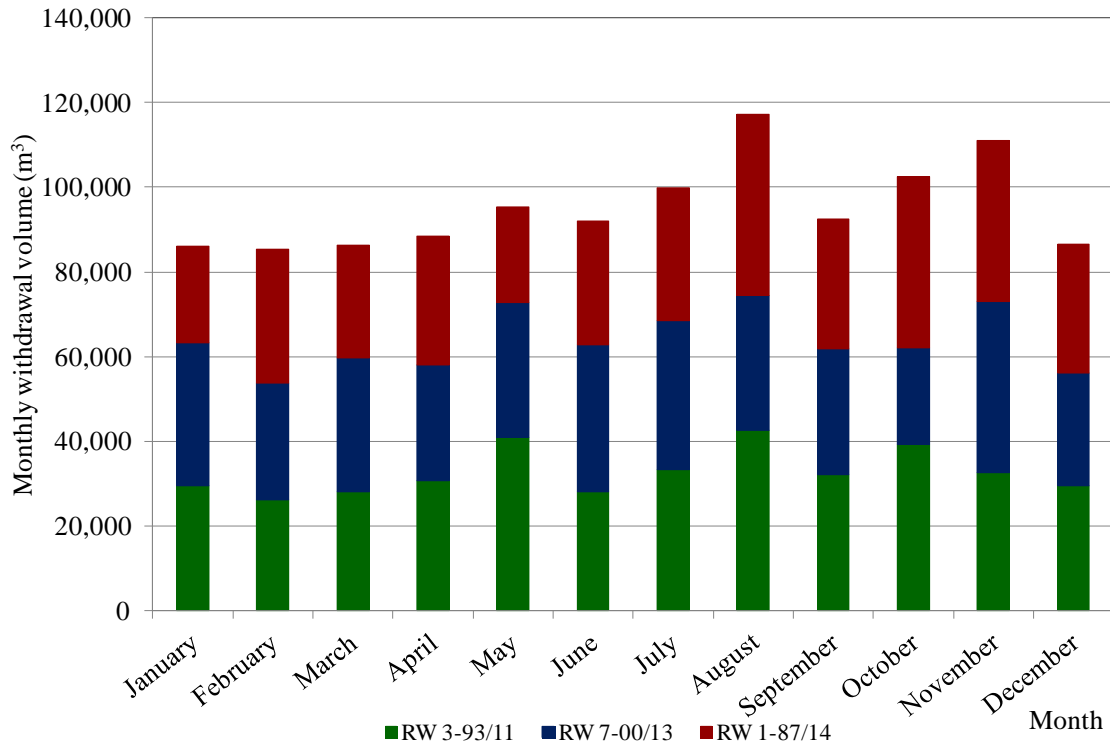
**FIGURE 2.1 | MONTHLY GROUNDWATER EXTRACTION VOLUME**

CWD's production wells have been successfully operating (in rotation) throughout 2016. **Figure 2.1 (next page)** shows the monthly groundwater extraction. For each month the figure shows the volumetric contribution of each well. In summary, for 2016:

- 1) The total volume of combined extraction is 1.09 billion litres;
- 2) Combined average monthly withdrawal is 90.7 million litres (ML); and
- 3) The combined average daily withdrawal volume is 3.0 ML.

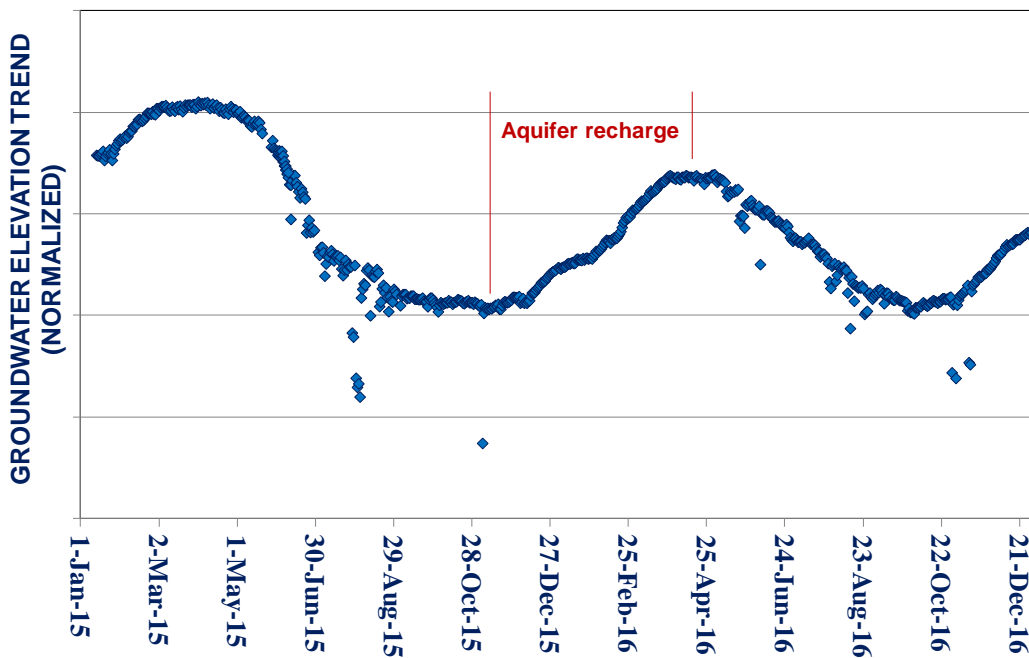
**FIGURE 2.2 | GROUNDWATER LEVEL TRENDS (MONITORING WELL)**

**Figure 2.2 (next page)** shows the (normalized) trend in groundwater levels for one of CWD's monitoring wells. The figure illustrates how the aquifer (i.e., hydrostatic level) responds to recharge (due to precipitation) within a year and between years; the trend suggests that the amount of recharge (and aquifer withdrawal) varies between years. **Aquifer recharge** occurs generally from late October - November to April - May, illustrated by the gradually increasing section of the sine-shaped curves.

CWD has been monitoring groundwater levels as far back as 1989. Throughout the years the groundwater level monitoring has been strengthened, and, since 2009 groundwater levels (in production wells and monitoring well) are monitoring on a continuous basis via SCADA. The data provides valuable insight in the variation in groundwater levels seasonally and between years. This is important information to ensure aquifer sustainability.

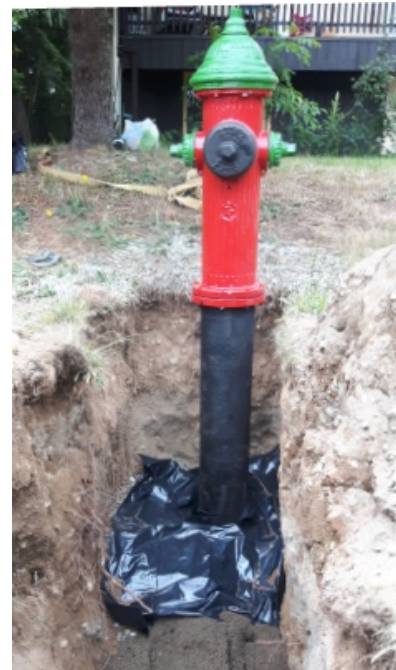
**IMAGE | FIRE HYDRANT  
INSTALLATION**

- Two new developments (multi-residential units) were constructed in Clearbrook. Together, these projects required upgrade of the water main (300 meters) from 200 millimetres diameter (200 mm) Ductile Iron (DI) to 250 mm Bionax® PVC Pipe (CIOD) (Bionax) at developers costs, and were installed by the contractor; CWD staff inspected the water main upgrade work on a daily basis. The work also included a 150 mm Bionax tie-in (loop) at one of the projects.

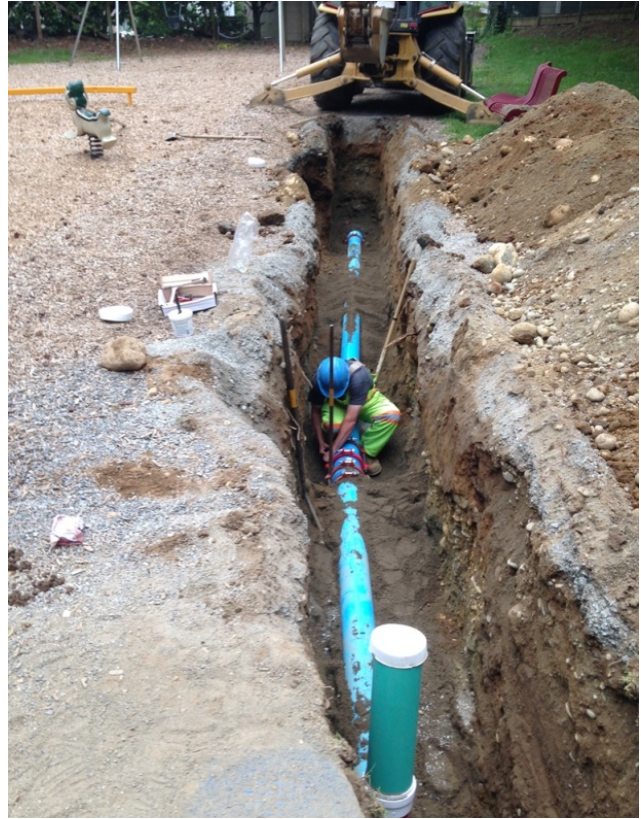
**IMAGE | WATER MAIN REPLACEMENT**

- Water system upgrading was completed at Charlotte Park; the work entailed: (i) the connection of three dead end water mains (connected at Charlotte Park); and (ii) upgrading about 500 metres (m) of water main: 150 mm and 200 mm of Bionax has been installed (upgraded from 100 mm and 150 mm AC pipe).
- The project also includes the connection of a new fire hydrant to the water system on Casper Court, and all of the twenty-two (22) residential service lines were upgraded from  $\frac{3}{4}$  inch (in) to 1 in di

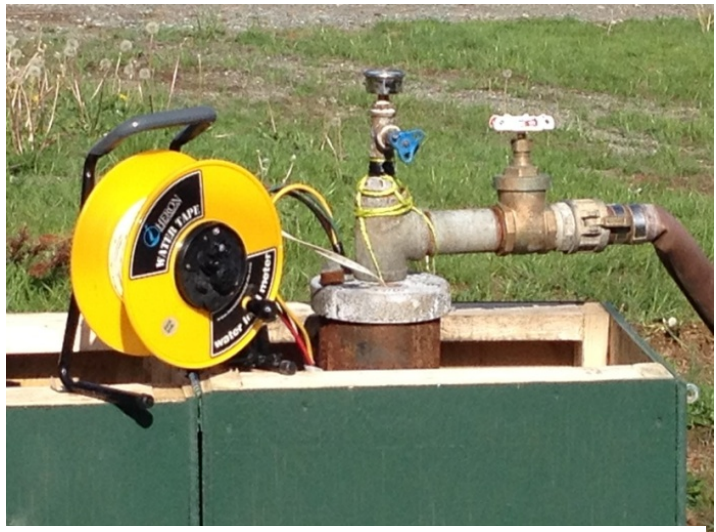
**IMAGE | GROUNDWATER MONITORING IN PROGRESS (SHORT-DURATION PUMPING TEST)**

Phase 2 of RW 2-63 Project was implemented in 2016, and which entailed the implementation of the groundwater monitoring program (groundwater levels and water quality) for the test well constructed for future well RW 2-63 (the test well was constructed under Phase 1 of RW 2-63 Project in December 2015). KWD has summarized the results of the groundwater monitoring program in a consulting report (Phase 1 and Phase 2 reporting for RW 2-63 Project).

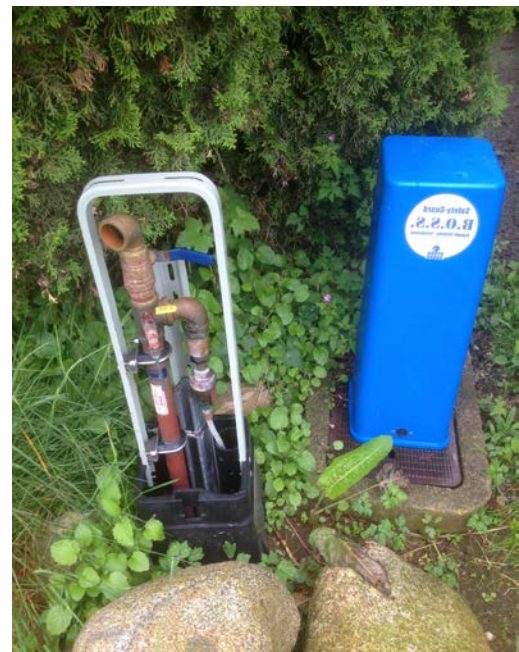
**IMAGE | SAMPLE STATION**

Therefore, as a water purveyor we are required to have our water analyzed to confirm the absence of selected microbiological parameters by an accredited laboratory. This entails the weekly monitoring of our water supply and distribution system: CWD has 25 water sampling locations throughout the District which, and on a rotating basis, are sampled and analyzed for *Total Coliforms* and *Escherichia Coliform (E.coli)*. Furthermore, water samples are collected from the wells and reservoirs, and analyzed on the required microbiological parameters. The results of the
